## Damage to agricultural facilities

Yoshiyuki Mohri\*, Susumu Masukawa, Toshikazu Hori, Mitsuru Ariyoshi

*Department of Facilities and Geotechnical Engineering, National Institute for Rural Engineering, Japan*

**Abstract**

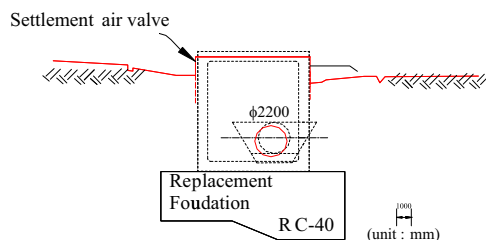
Fig. 6. Cross section for Gohonmatsu diversion.

As shown in Fig. 6 and Photo 1, the soft ground foundation for the diversion works was replaced with crushed gravel to improve the bearing capacity. For this reason, the embankment of the structure settled only 100 mm deeper than the design elevation, but extensive settlement of the surrounding ground created a bump of 500 mm between the diversion structure and the ground surface. Sand boiled by liquefaction was widely deposited on the surface of the surrounding ground. The upstream and downstream pipes connected to the structure settled 206 mm and 353 mm, respectively. The joints for the upstream and downstream pipes were ejected 360 mm and 465 mm at the crown of the pipes, respectively. The fact that the manholes and pipes generally settled suggests that the settlement of the ground at depths below the pipes was extensive, and the liquefaction of the backfill sand resulted in the considerable deformation of the pipes, causing them to be easily ejected and resulting in the fracture of the pipeline.

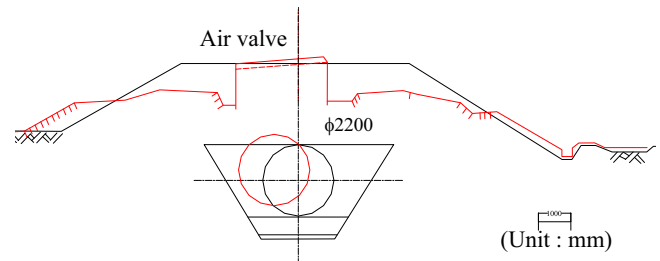
Fig. 7. Cross section for Yabuki-minami district (red line is after earthquake).

ground. The cause of the floating pipe is attributed to the liquefaction of the backfill soil, but no large-scale sand boiling was observed on the road surface. As shown in Fig. 7, the road for pipeline maintenance was constructed above the pipe under the embankment design, ensuring the given overburden. However, the road has complicated crossing structures, such as in close proximity to the embankment for the JR Tohoku Line (JR's fill is 5 m from the toe of the slope on the right bank). The JR embankment also meandered and subsided, resulting in a stoppage of train operations. A landslide occurred on the part of the slope in the left bank. It was suggested from this behavior that the liquefaction of the backfill sand for the pipe induced settlement and the landslide of the embankment above the pipe.

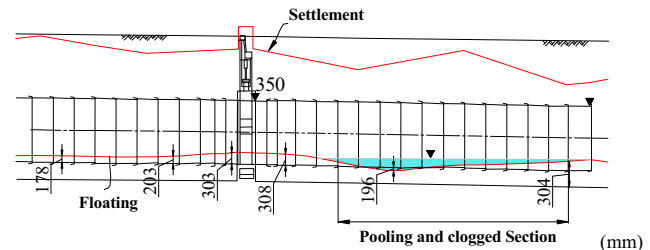
Fig. 8. Settlement of pipeline around manhole, Yabuki-minami (red line is after earthquake).

The pipes connected to the air valve structure, shown in Fig. 8, were greatly deformed. The pipe at the joint was ejected 350 mm, while the pipes connected to the upstream and downstream sides of the structure settled 363 mm and 338 mm, respectively. Pipes with a total length of at least 130 m floated more than 100 mm. The horizontal deflection of the pipe was measured at five representative points. The results showed that its deflection was 16 (deflection rate of 0.7%) to 65 mm (2.9%).

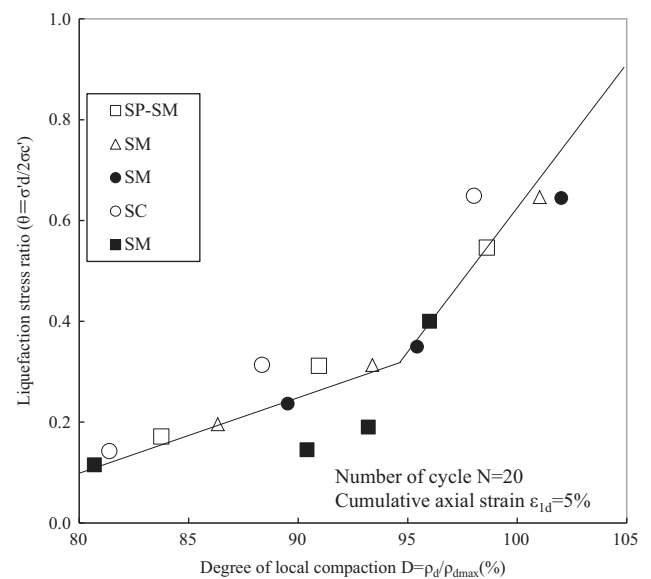
Fig. 9. Liquefaction resistance of backfill sand.

In the section of pipeline where the sand equivalent to SF was adopted as the backfill material for the pipes, the grain-size distribution of the sand shows a high risk of liquefaction. This sand is considered incapable of fully mobilizing its resistance to liquefaction, considering the degree of local compaction (a  $D$  value of 88–99% when compared with the standard Proctor maximum density). Fig. 9 (Ministry of Agriculture, Forestry and Fisheries 2009) shows the relationship between the liquefaction stress ratio ( $\theta=\sigma_d/2\sigma_c$ ,  $\sigma_d$ : the amplitude of repeated deviator stress,  $\sigma_c$ : consolidation stress) of sand used as backfill material and the degree of compaction of the sand in the pipeline districts that were previously damaged by an earthquake. These types of sand (SC, SM and SF materials) which are specified as quality backfill sand in the Design Standard (Ministry of Agriculture, Forestry and Fisheries, 2009), in case of liquefaction stress ratio of 0.4 or less and  $D$  value of 95% or less, are not considered to have sufficient density in order to avoid liquefaction for severe earthquake like as the 2011 off the Pacific Coast of Tohoku Earthquake. Since the backfill sand in the relevant district has a

$D$  value of about 90%, the liquefaction stress ratio of the sand is estimated to have been about 0.2–0.3. Based on the above discussions, it was decided that crushed gravel is the most suitable for use as backfill in order to improve the resistance to liquefaction in restoring the damaged pipeline sections. Also, in facilities with settlement or floating of concrete structures,

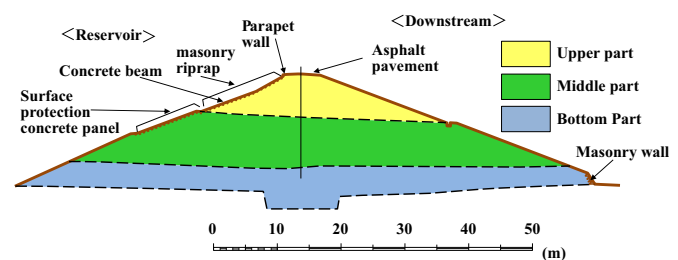
Fig.13. Cross section and classification of embankment layer.

- (3) The middle embankment layer was between 7 and 9 m thick, consisting mainly of brownish gray sandy silt with alternating 20–30 cm layers of sand containing yellowish-gray silt, loam-type clay, and humic silty sand ranging from black to dark gray, and showed clear traces of spreading.

- (4) The bottom embankment layer between 4 and 6 m thick, consisted mainly of coarse to fine sand contained gravel including a silt fraction, with alternating 20–30 cm layers of loam type clay and humic silty sand ranging from black to dark gray, and showed clear traces of spreading.

In the Design Standard (Ministry of Agriculture, Forestry and Fisheries, 2009), the stability of the dam embankment has to be estimated by a circular slip analysis. The safety factor by the criteria based method of stability analysis using the soil strength *c'* and *φ'* (Table 4) was 1.15 less than the required value of 1.2 of the criteria when a seismic force of 0.15, which is regulated as a severe earthquake district in the Design Standard (Ministry of Agriculture, Forestry and Fisheries, 2009) is applied to the upstream direction. The cross section for analysis is indicated in Fig. 13.

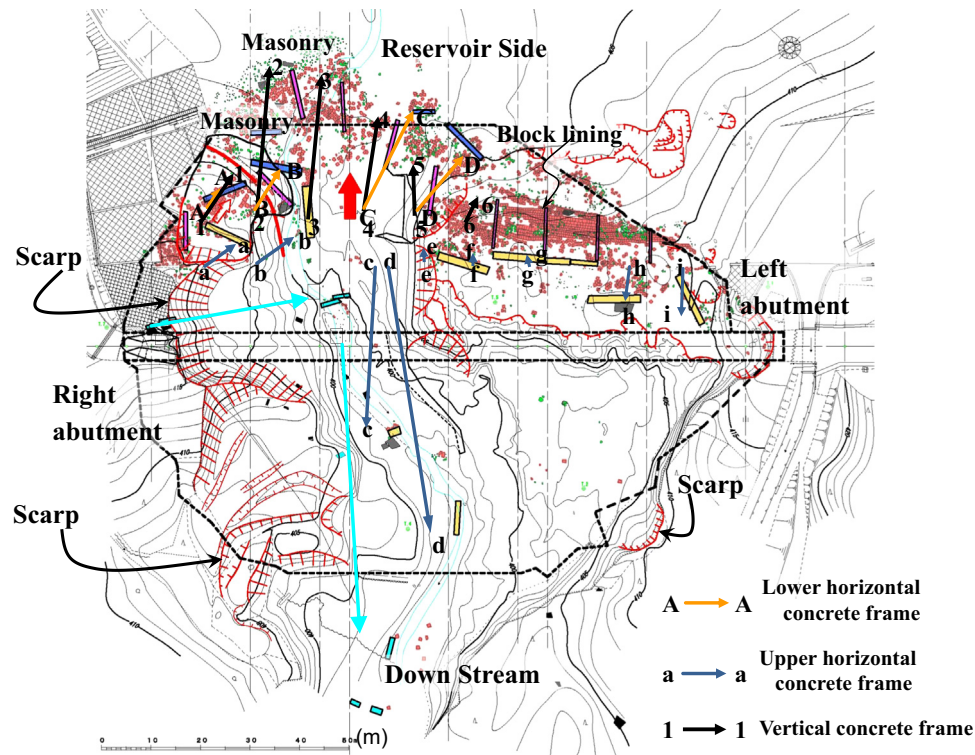
The investigation revealed that the slides could be broadly classified into seven stages (Fig. 16). Among these slides, the upstream slide Nos.1 and 2 triggered the subsequent overflow and erosion and resulted in the failure of the dam (Fig. 17). The slide failure No.1 occurred in the upper embankment, as was recognized from the remnant of the structural elements in the reservoir, as shown in Fig. 15.

Fig. 15. Mapping of structural elements after failure (quoted from Tanaka, 2012). *Notes:* The dot colored blue is the parapet wall. The dot colored green is masonry riprap. The small square colored purple is the surface protection work. The rectangular colored yellow is concrete beam on the upper upstream slope. Most structural elements moved to upstream.

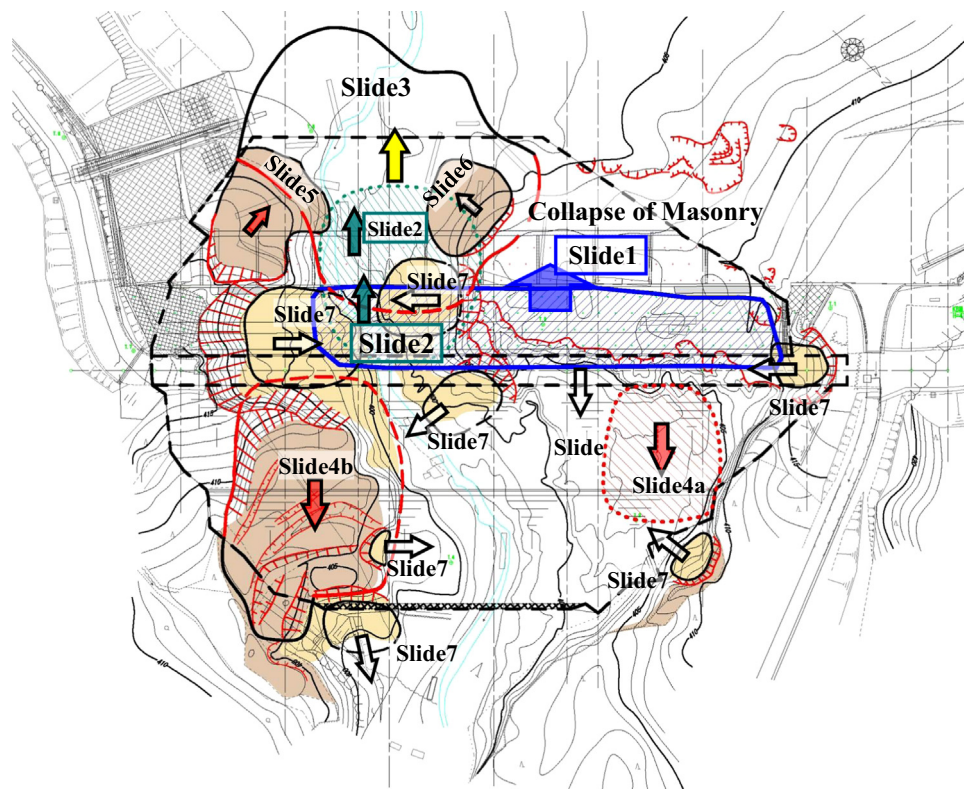
Fig. 16. Integrated map of slides of the Fujinuma main dam (quoted from Tanaka, 2012). *Note:* The solid lines are existing slide bodies. The broken lines are estimated slide bodies which were lost by wash out.

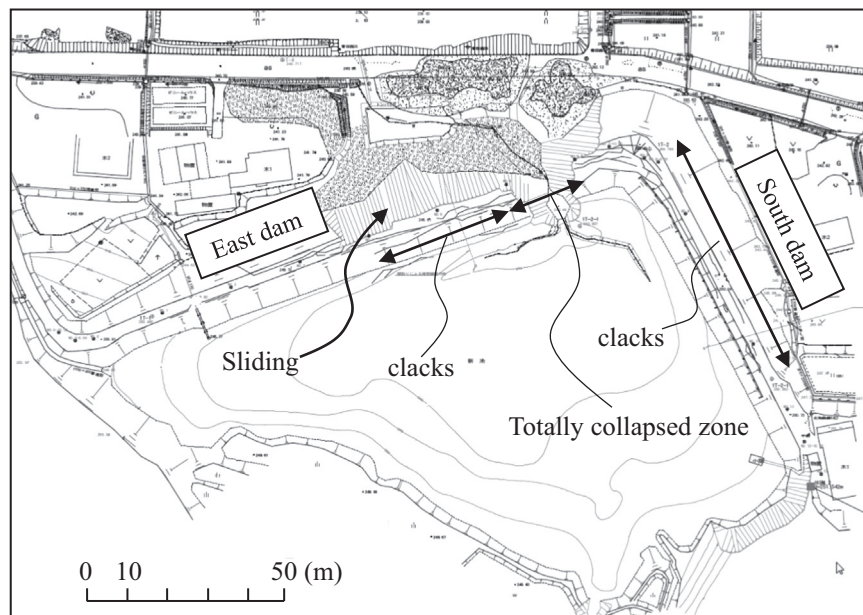
Fig. 18. Plan of Aota-shin small dam after breach.

The reservoir was full when the earthquake struck, breaching the connection point of the east dam and south dam, discharging all the water in the reservoir (Photo 6). The crest was cracked over its entire surface including the east dam and south dam, and the downstream slope of the east dam (left bank side of the breach) had slide failure. Inundation caused by the breach passed through the houses to flow into downstream paddy fields and small earth dams, but the breach caused no secondary damage to the residential homes.

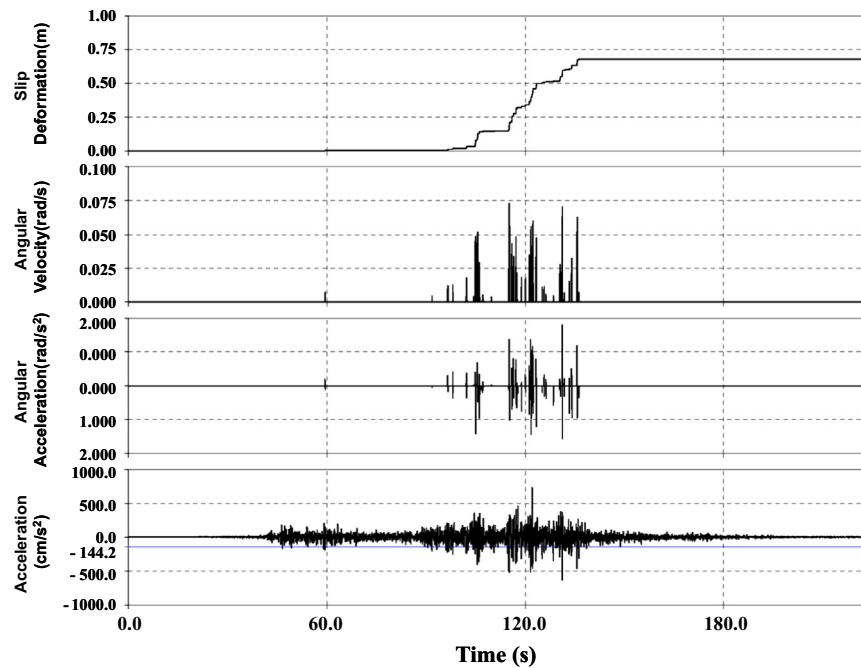
Fig. 19. Calculated deformation of the Aota-shin small dam by the Newmark method.

The results of an investigation of the part left after the breach have confirmed that the dam has a uniform soil structure made of clay (Hori et al. 2012). Undisturbed specimens were taken from the remaining part of the dam and provided for triaxial compression test, showing that the strength of the dam soil is  $c_d=40 \text{ kN/m}^2$ , and its internal friction angle  $\varphi_d=28.0$ . Examples of the results of using the strength of the dam material obtained by the triaxial compression test to calculate the quantity of deformation by the Newmark Method are shown in Fig. 19. The input earthquake motion used was that recorded at the Koriyama Observation Station observed by K-NET. The analysis has shown that the sliding displacement  $\delta$  and the minimum safety factor  $F_s$  which were calculated are  $\delta=0.7 \text{ m}$  and  $F_s=0.99$  respectively under sliding failure of the upstream

slope. That is, the settlement of about 0.7 m obtained by the analysis results is not sufficient to explain the failure of the dam.

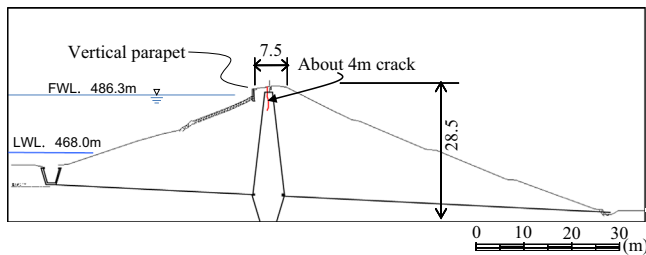
Fig. 20. Cross section of the Mitsumori small dam and depth of the longitudinal crack.

The Mitsumori small dam was full when the earthquake struck, and a longitudinal crack about 130 m long formed on the crest of dam as shown in Photo 7. On the dam on both sides of this longitudinal crack, the upstream side settled lower than the downstream side, forming a step with maximum height of about 60 cm. The concrete vertical parapet on the upstream slope shoulder fell slightly, and this deformation ripped up the masonry directly below the parapet in a scale-like pattern. On the downstream slope about 11 m below the crest, the masonry bulged outwards over the entire dam axis direction (Photo 8). The longitudinal crack on the crest of dam might actually be two cracks. One could have been caused by

the parapet, which was vertically raised, being inclined upstream by the earthquake, causing tension cracking of the extra banking. In this case, the damage was limited to around the extra banking. The second could have been caused by large sliding failure towards the upstream side of the dam. It was feared that aftershocks and the rapid drainage of the reservoir water might induce a sliding failure. In order to confirm the depth and direction of the crack in the crest, slaked lime diluted with water was poured into the crack and, after the crack was colored, a trench was excavated in the cracked part of the dam. The results confirmed that the crack had advanced to a depth of about 4 m in the vertical direction from the crest as shown in Fig. 20. Therefore, it revealed that the deformation of the masonry was limited to the masonry layer being displaced downwards locally by the earthquake, but large
